Inspection Report

Minerals Regulatory Program

Mine Name: Cameron #1
Operator Name: TME Asphalt Ridge, LLC

Permit number: M0470036
Inspection Date: November 1, 2006
Time: 7:50-9:35 AM

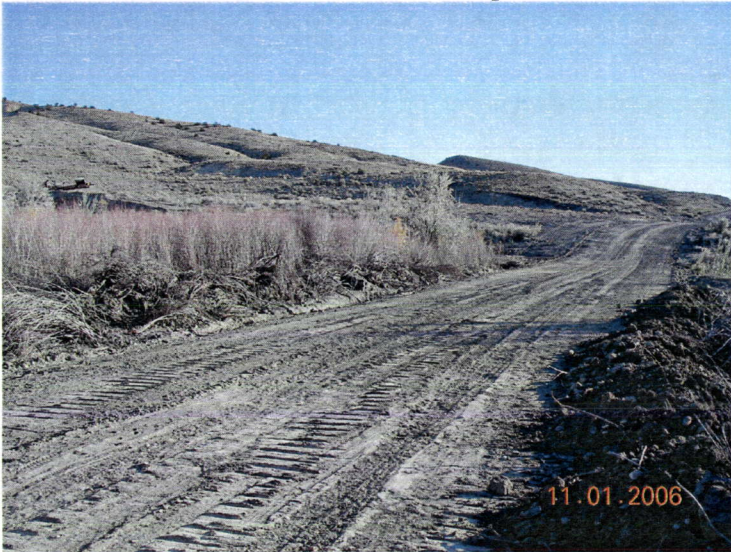
The operator has widened the road coming into the site, including the portion across the stream (Photo 1). The area next to the stream (to the left in Photo 1 and to the right but not shown) would probably be classified as a wetland: nearly all of the vegetation is willows. Fill material has been pushed into this area.

The area next to the road shown in Photo 1 is probably a wetland, and if it is, putting any kind of fill into this area without a permit from the Army Corps of Engineers is a violation of the Clean Water Act. I have reported the activity to the Corps and assume they will investigate and make their own determination whether a violation has occurred.

Photo 1. The road across the stream. The total disturbance width is about 40 feet. Note the willows on the left; they are on both sides of the road.

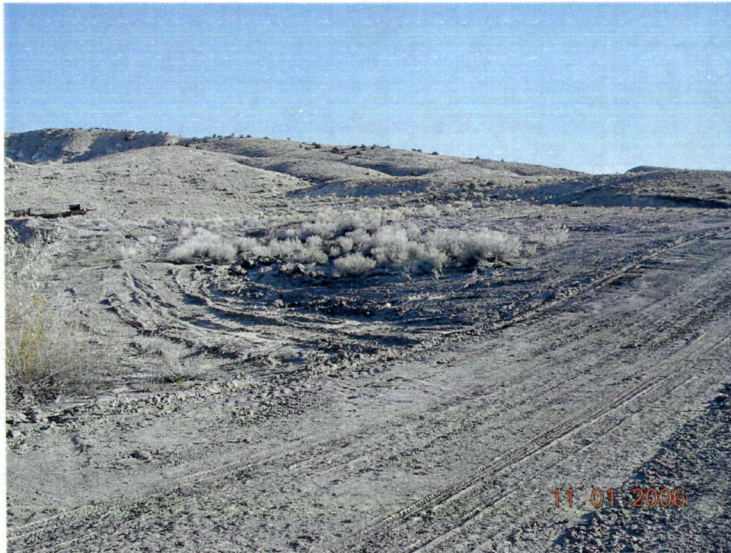
There is no sediment control between the regraded/seeded area and the stream (Photo 2).

Photo 2. A portion of the area between the regraded/seeded area and the stream.

Sediment control should be installed between the regraded/seeded area and the stream (Photo 2).

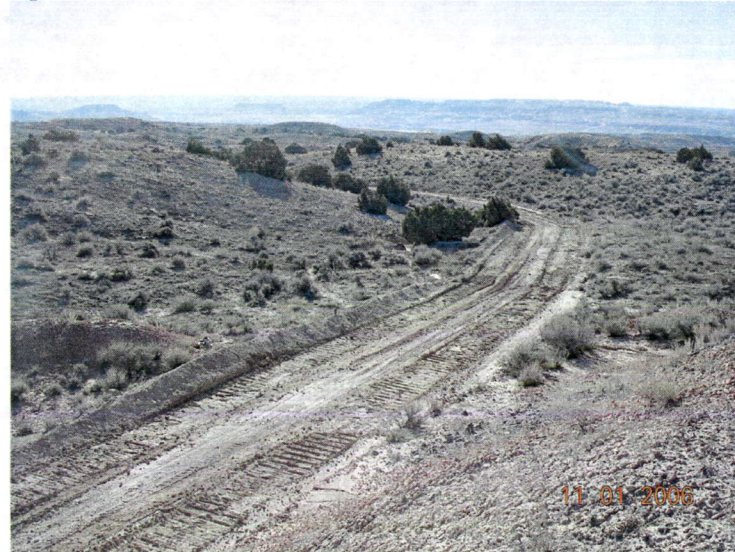
The road leading to the substation has been graded (Photo 3).

Photo 3. The road leading to the substation and water tank/line.

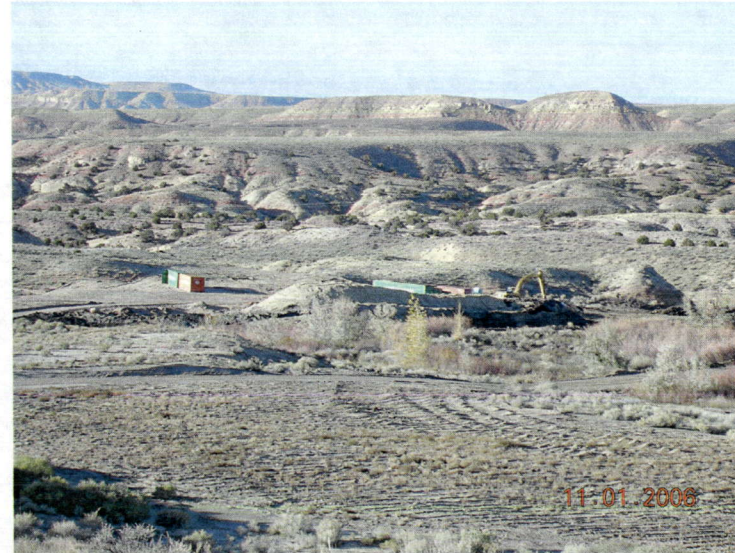
In the fall of 2005, the operator graded and seeded a 2.04-acre area (yellow area on the attached map; foreground of Photo 4). I could not see any signs of germinating vegetation when I visited the site last spring, but during the current inspection I was able to find some grass seedlings. It is impossible to identify these seedlings with certainty, but most did not appear to be cheatgrass. I believe some seed may have survived and is just now germinating because of recent heavy rains in the area. In addition to the grass seedlings, the area contains a fair amount of dried up halogeton.

Photo 4. The area in the foreground was regraded and seeded in 2005.

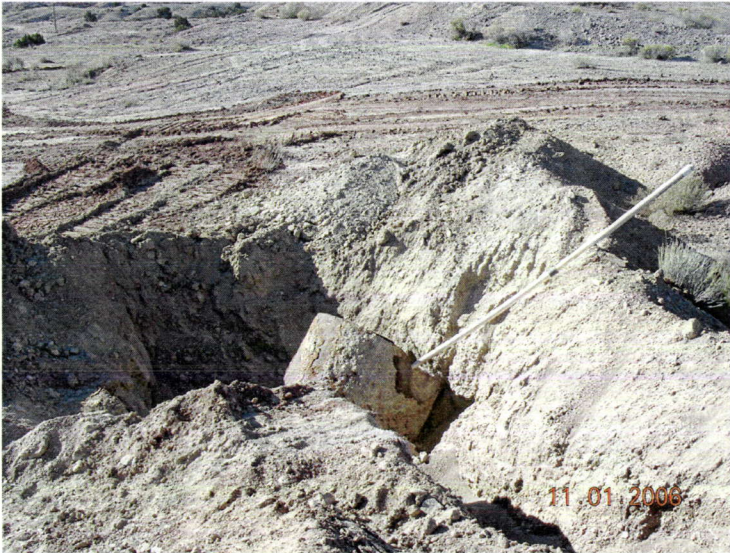
Photo 5. The water tank and part of the water line near the substation.

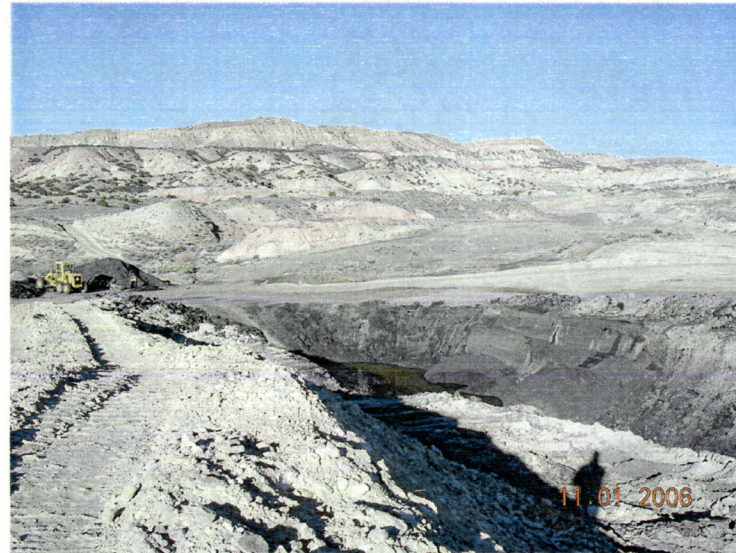
The operator has expanded the disturbance in a few areas. These include the road coming across the stream which now has a total disturbance width of about 40 feet, the road to the substation which has been graded and should now be included as part of the disturbed area, the water tank and water line near the substation (Photo 5), an area with two portable storage units (Photo 6), and an area next to the pit that was formerly undisturbed (left side of Photo 7).

Photo 7. The area on the left is new disturbance. The pit is on the right.

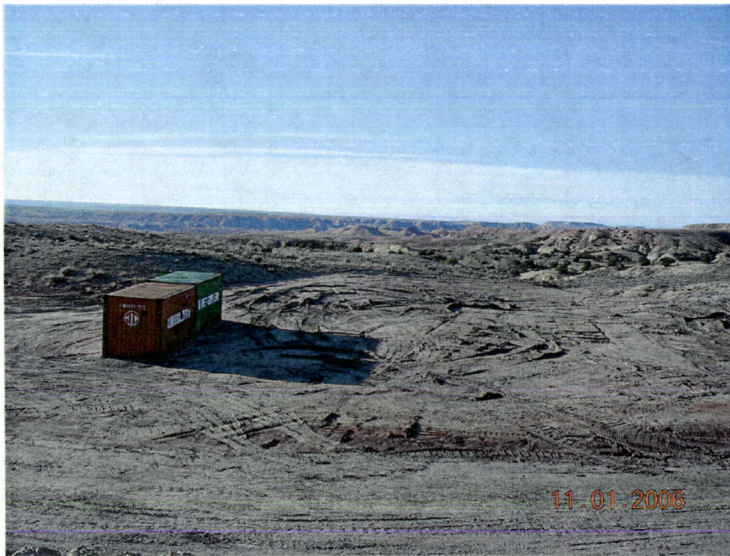
Photo 6. This pad is new disturbance.

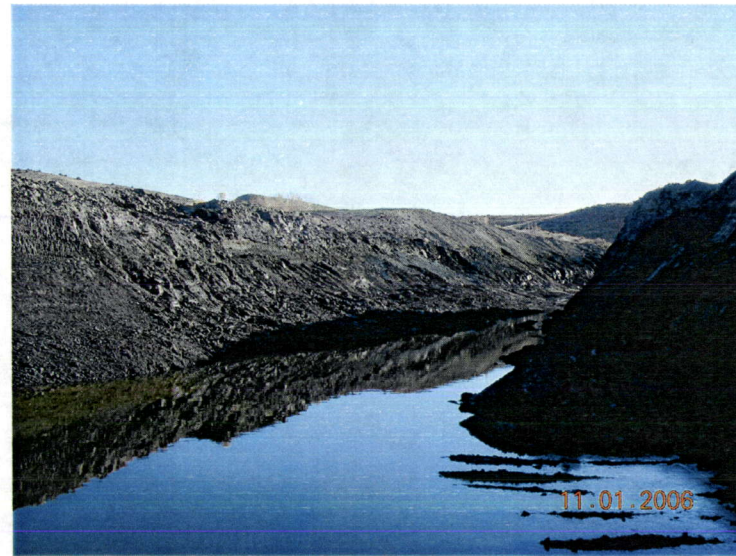
Photo 8. Another view of the pit.

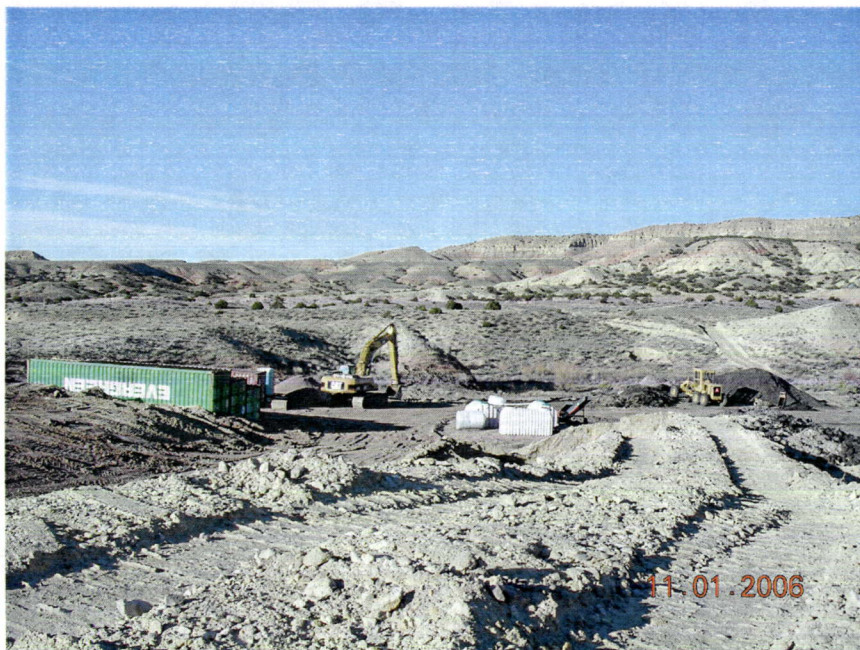
Photo 9. The main operations area.

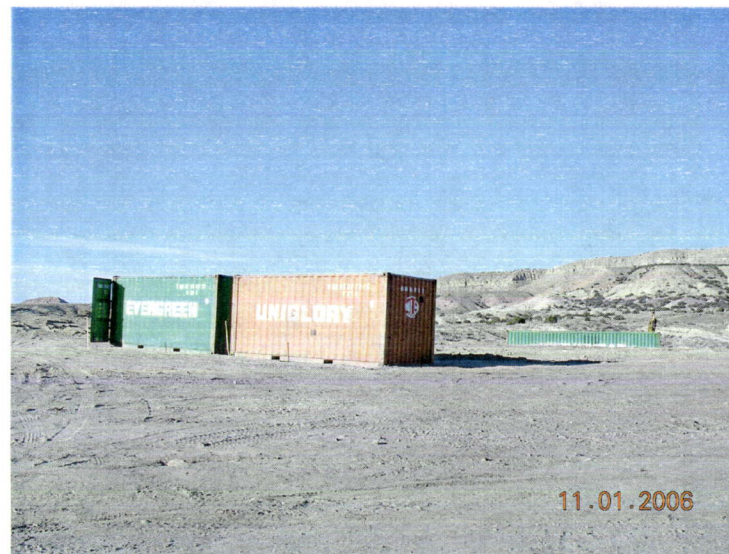
Photo 10. Another view of the area shown in Photo 6.

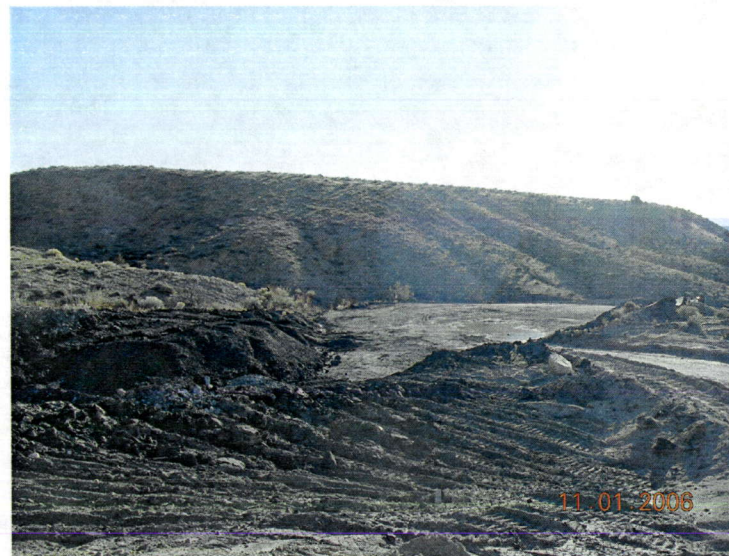
Photo 11. The area in the foreground is new disturbance. This view is looking approximately southeast, parallel to the pit.

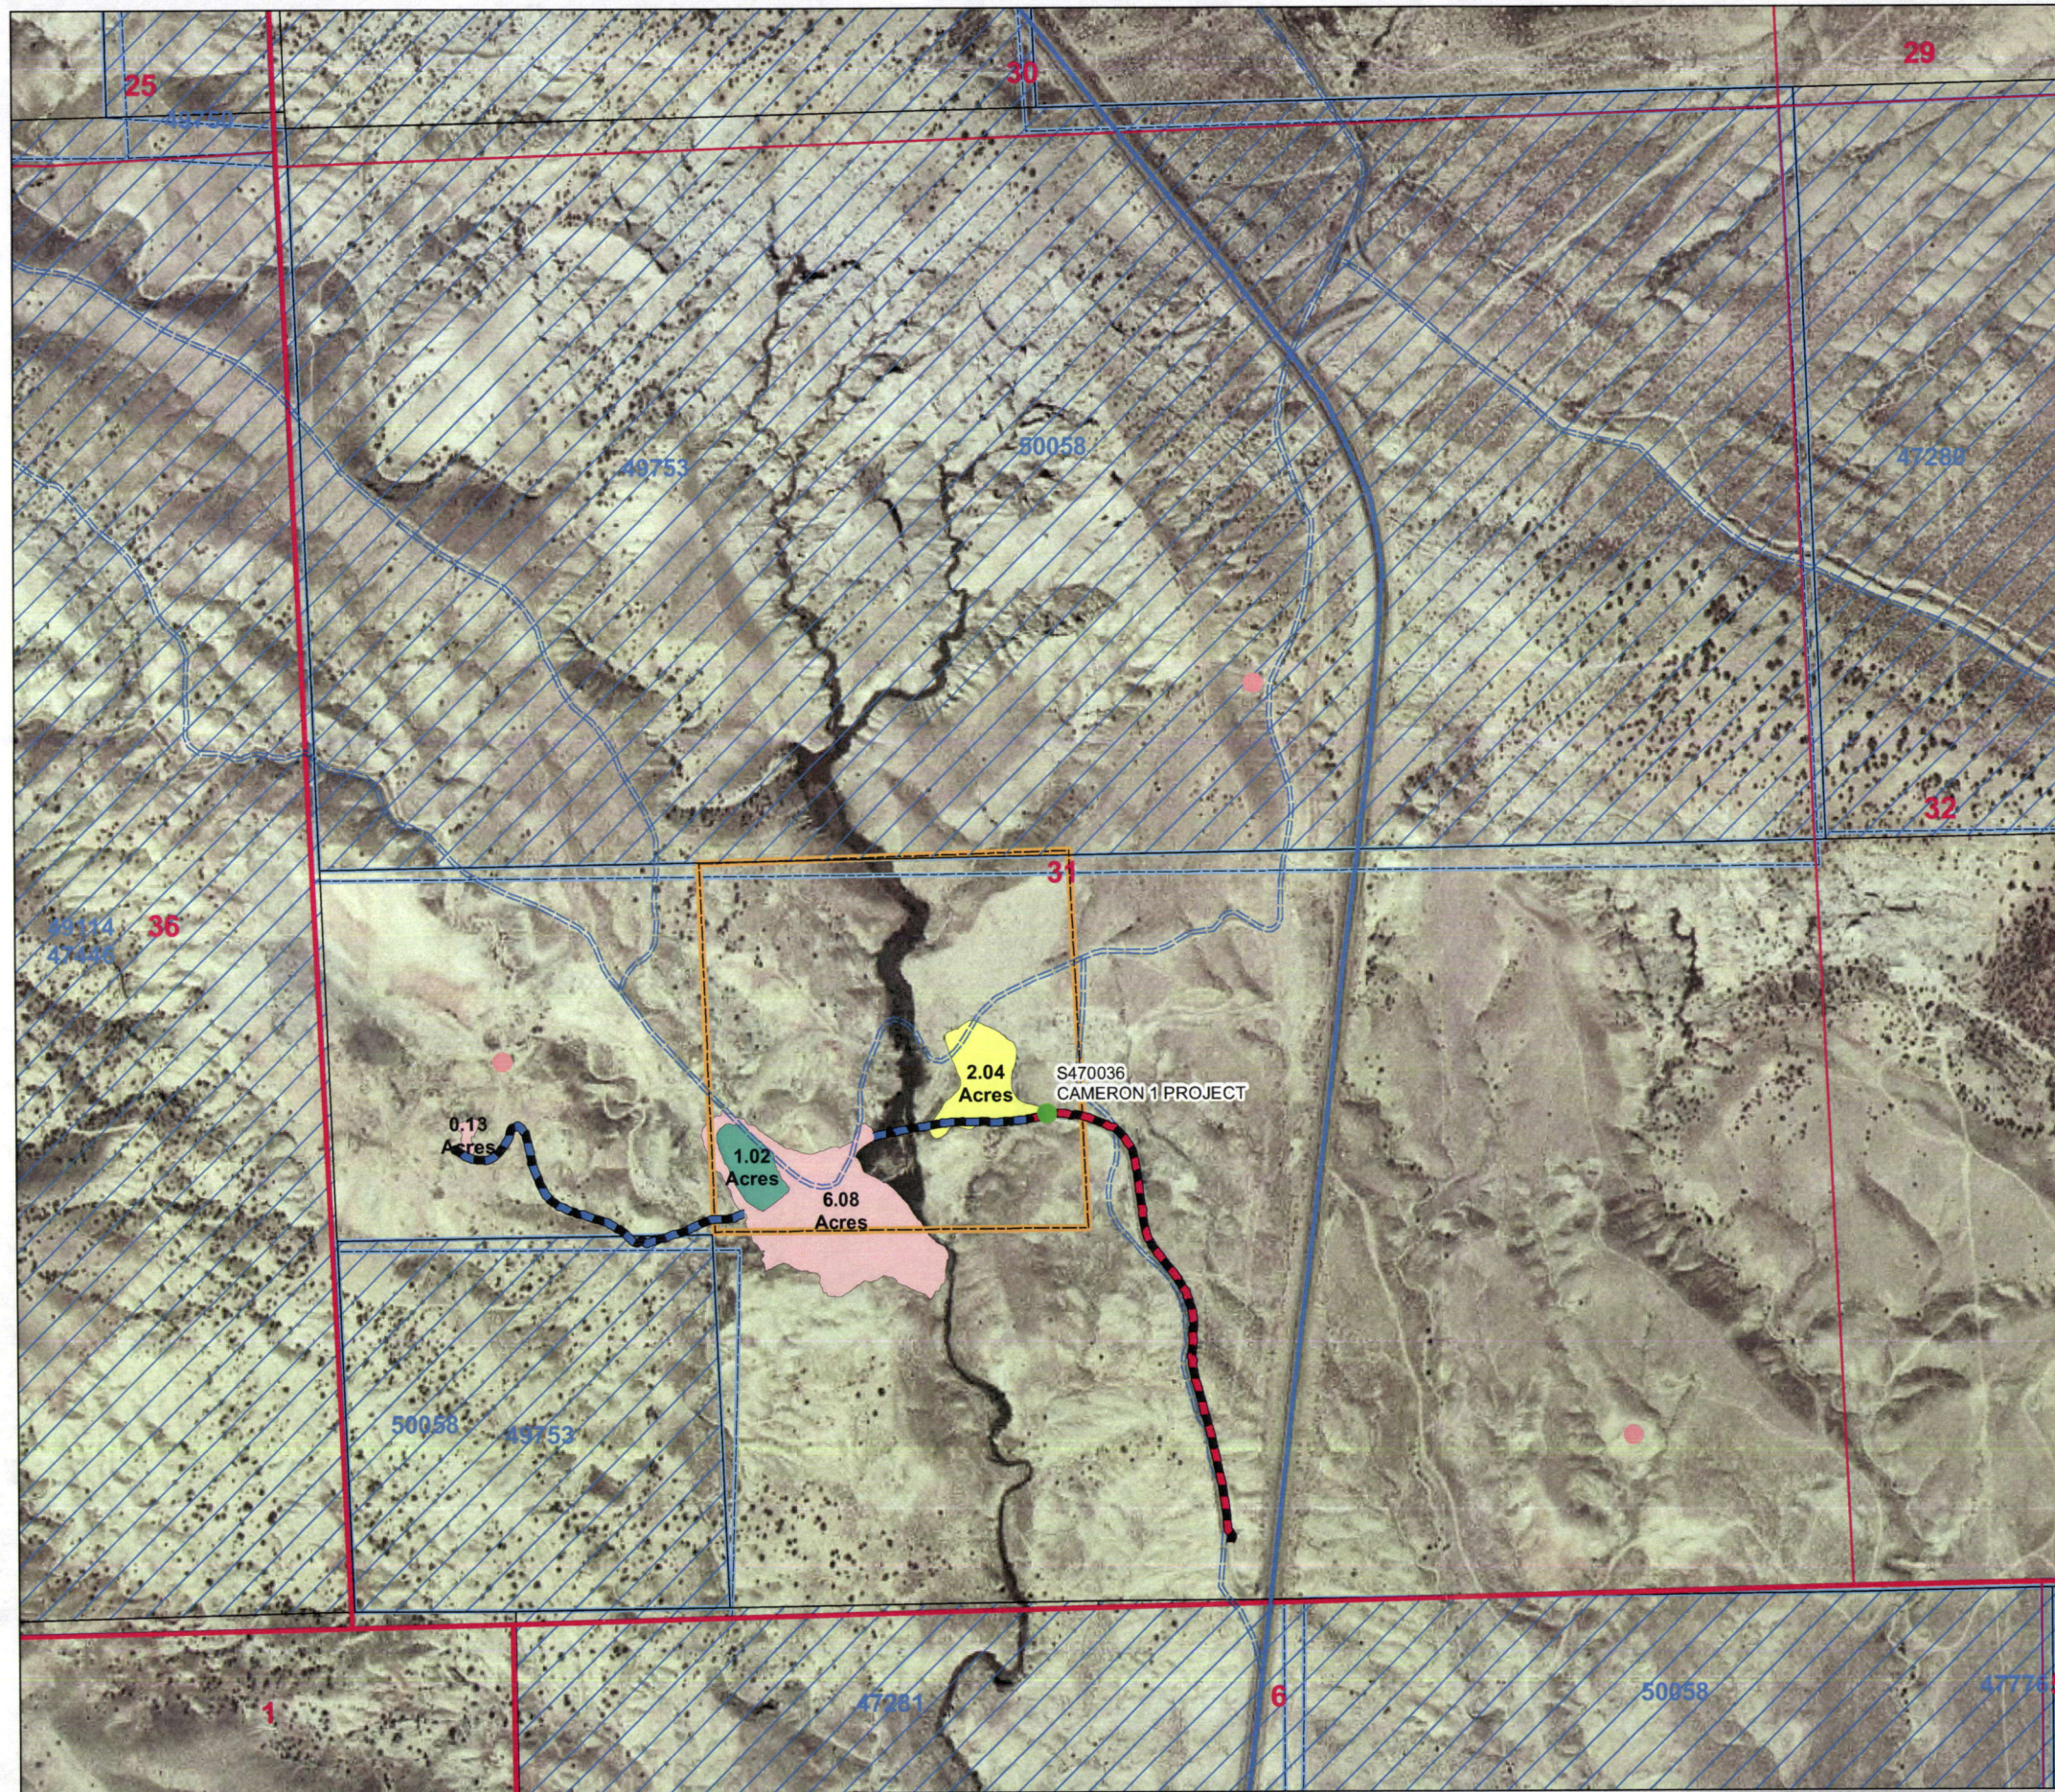
I used a GPS unit to map the disturbed area, and a copy of this map is included with this report. The total disturbed area is 9.28 acres which includes 2.04 acres that was graded and seeded in 2005 (yellow on the attached map). This figure also includes all those areas mentioned above, but it does not include the road from SR 45 to the regraded/seeded area (red and black on the map). It also does not include a 1.02-acre area, in blue-green on the map, that may have been disturbed at some time in the past.
